AWA Newsletter

Issue 32

August 2008

Yeadu FT501 Restoration- By: William-ZS4L

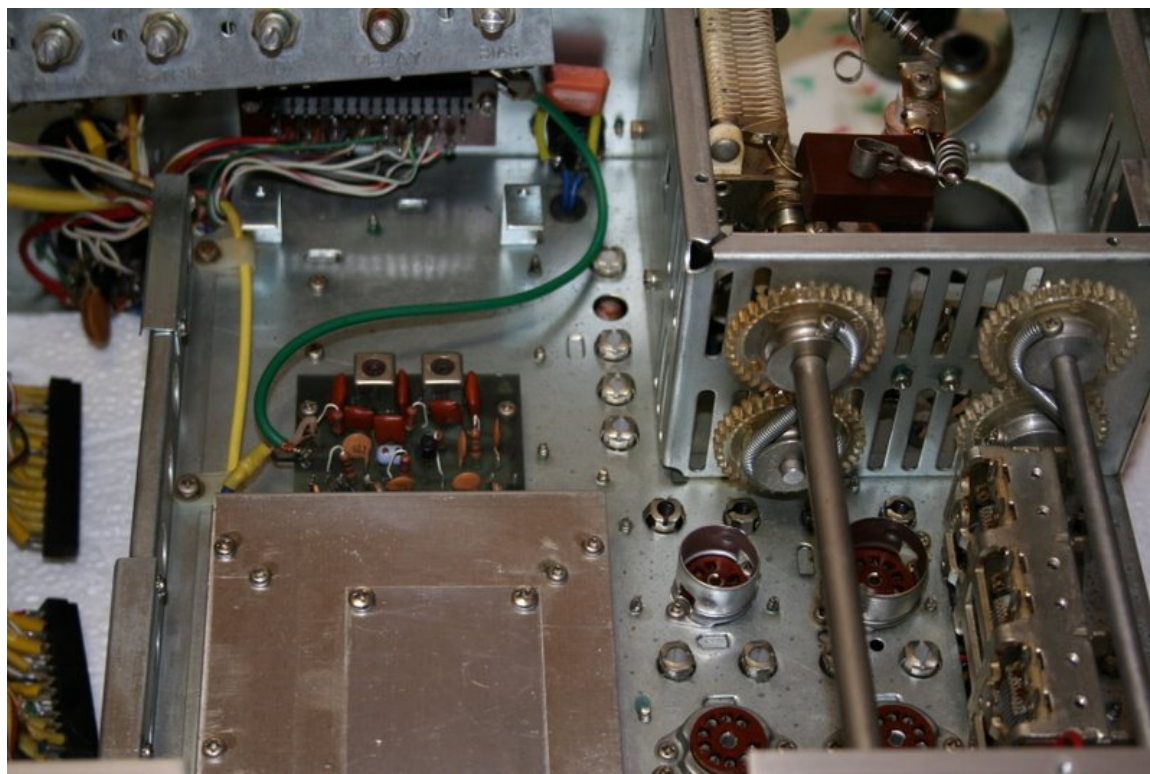
The Chassis after cleaning , cleaning and more cleaning!

This particular rig had spent most of its' life at the coast, so pit marks / oxidation was quite apparent on the chassis and covers-and so first task ahead was to clean the rig.

A compressor was used to remove the years of accumulated dust-care was taken not to damage the 'S' meter and capacitor vanes!.

The chassis was then painstakingly cleaned using Mag Wheel cleaner and cotton buds. A very slow process!. When the chassis was clean, the cleaner had to be neutralised using warm water on a cotton bud.-(It contains a slight amount of Caustic Soda-never apply this to painted surfaces!)

The chassis was then sprayed down with Servisol, including the wafers, pots , shafts , Variable caps, valve bases and anything else that looked a bit cruddy.

Once again the chassis was blasted with compressed air to remove the excess Servisol.

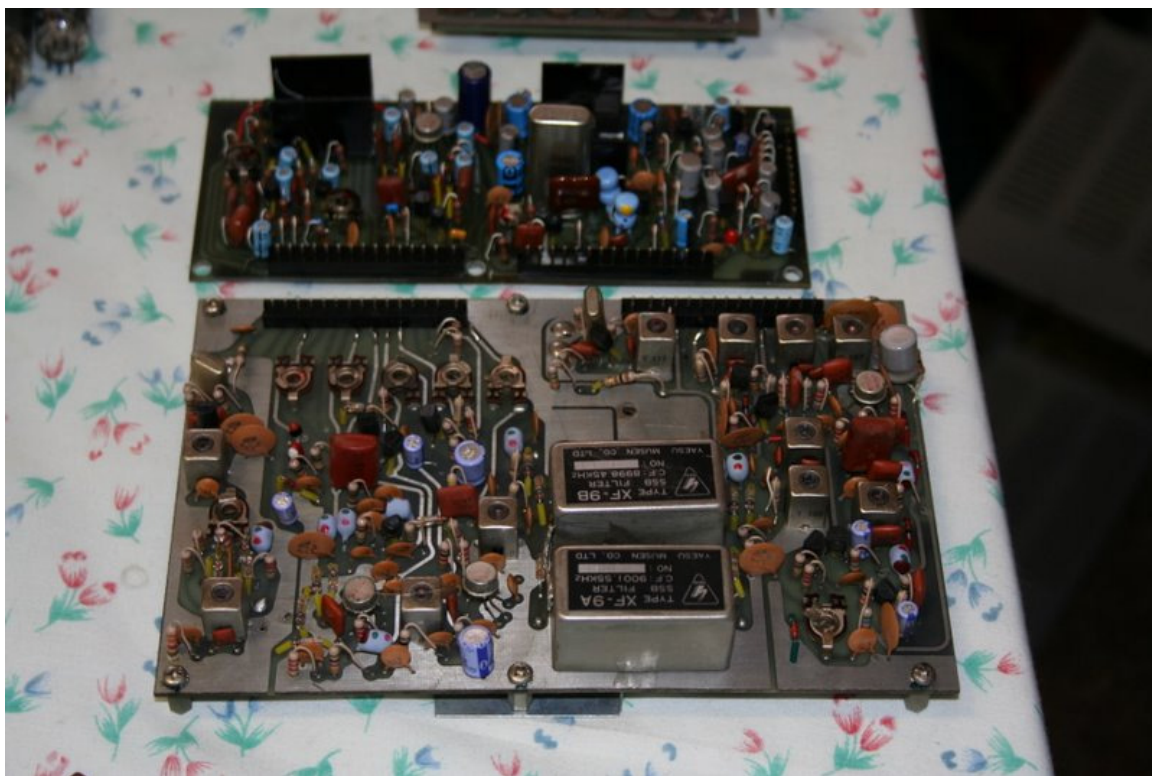
Audio and IF Boards (Cleaned with thinners-You have to be quick!)

The Audio and IF boards were tackled first-it is always a good idea to replace suspect/leaky capacitors-and decoupling capacitors as a rule-so this was tackled with great gusto, and when I looked again, a whole pile of used capacitors had been accumulated!. Some ceramic caps had split-and some electrolytic's had swollen and were about to do the same .(Split too!.) Sometimes a cap will test fine-but it still has a very high internal resistance (reactance), and best rule is , when in doubt, throw it out! . This is especially true of inter stage caps in valve rigs where the driver stage is coupled from anode via a blocking cap to the grid of the next stage-this fault could be quite disastrous when a cap becomes leaky, case in point the old FT101 rigs- some of them literally went up in smoke when the owner looked the other way-but I digress..

The Counter was tackled next-some clever guy had used candle wax on every coil / IFT in the entire set, (Bless his soul!.) the Counter of course was not spared, and all the slugs had to be unseated using a hair dryer on low temperature-I lost 2 slugs in this process, (Eish!)-and had to be replaced. (Proper tuning tools are a must by the way!.)

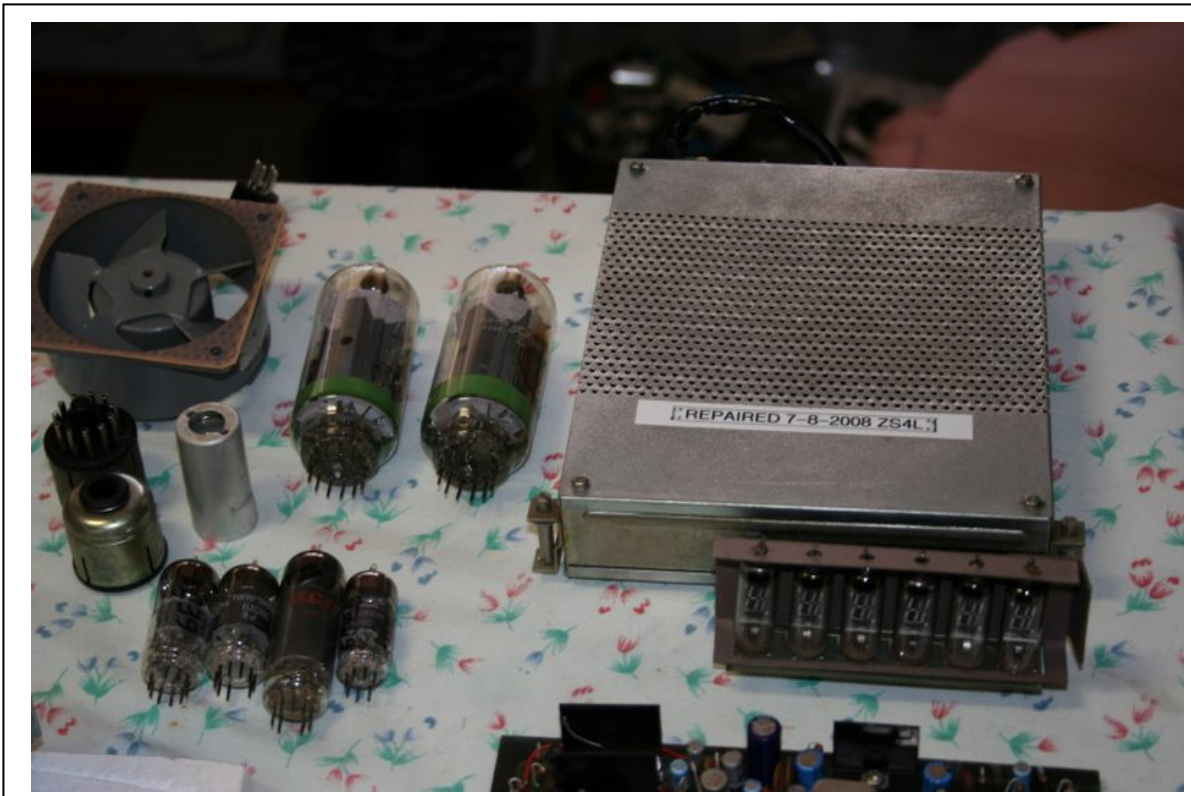
The LSD nixie tube would not work-and although the counter IC502 was being strobed-no outputs were high from this chip. I unsoldered the sucker using the soldering iron and compressor-(old double-sided PCB.s have a tendency to peel when components are removed, so I decided to use the messy, but safe method..!).

I replaced some decoupling caps and checked the display-Hoorah, it was working!.

Whilst working on the display, the starting cap for the cooling fan gave up the ghost-(a one microfarad 250v non-polarised .) This was temporarily replaced with a .63 micro cap until I received the replacement capacitor.

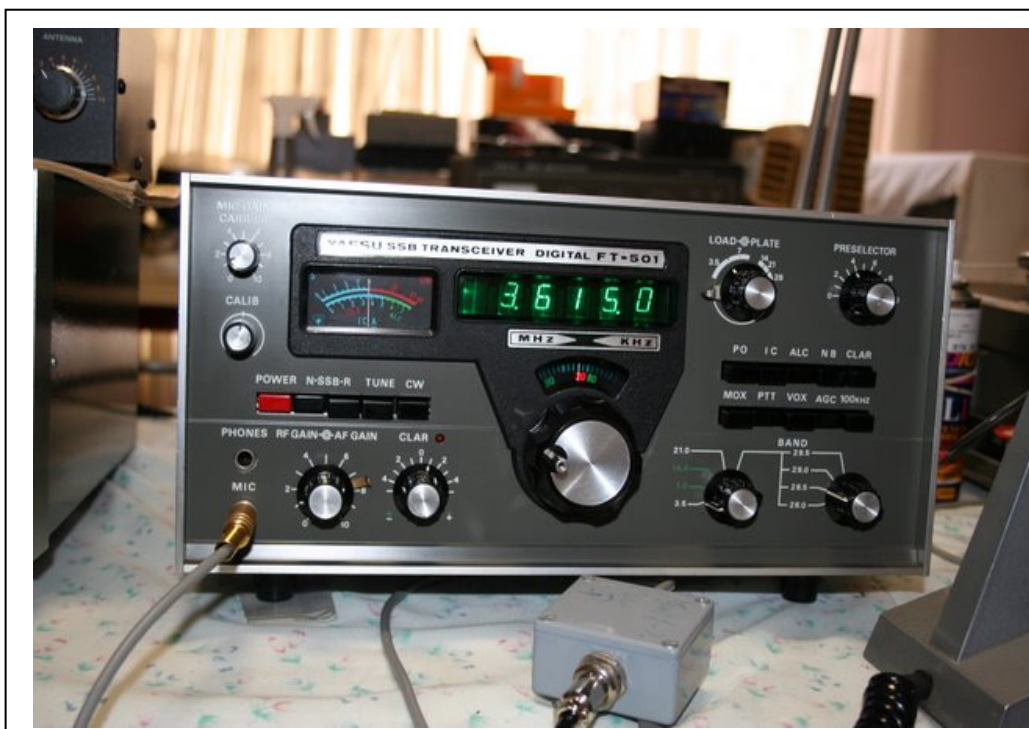
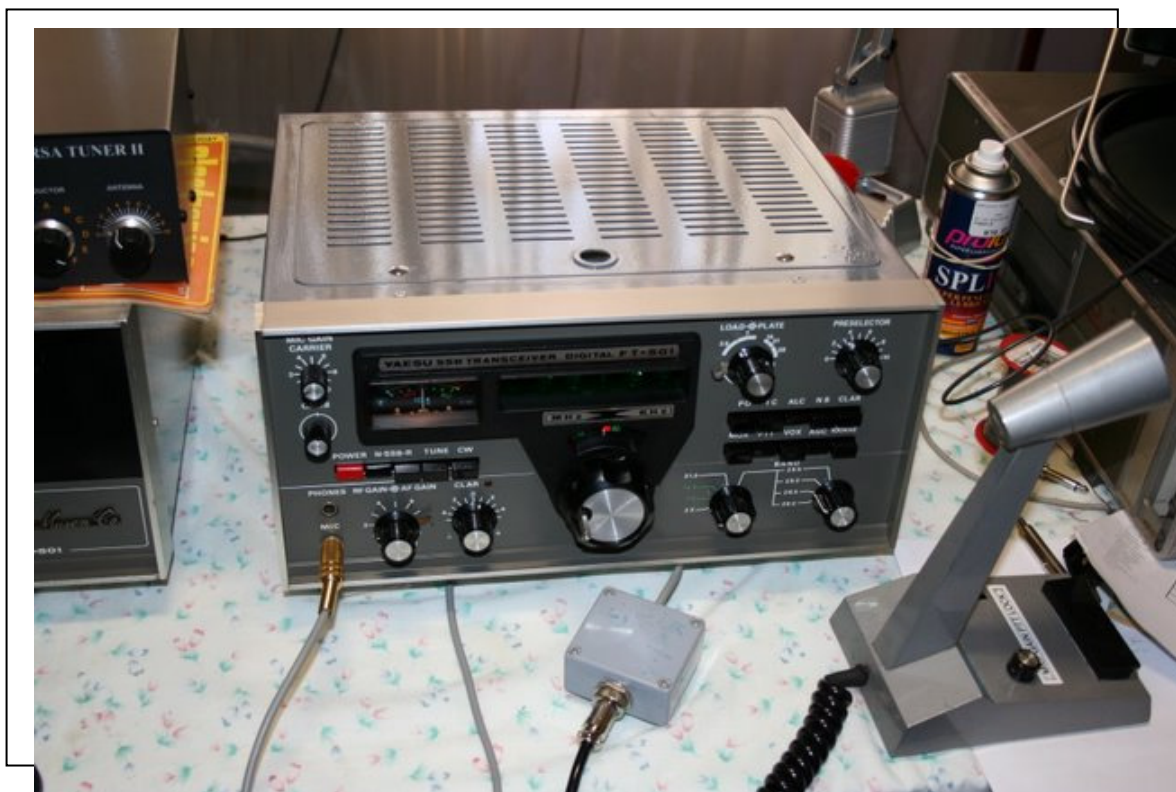
Having used the rig a couple of times I must say that the results are very gratifying-and as a bonus the audio on transmit seems very good matched with the Turner microphone.

The covers were sanded and spray-painted. Still want to powder coat them though.
