## Antique Wireless Association of Southern Africa Newsletter

# 190

May 2022

## Wireless Aboard the Titanic...

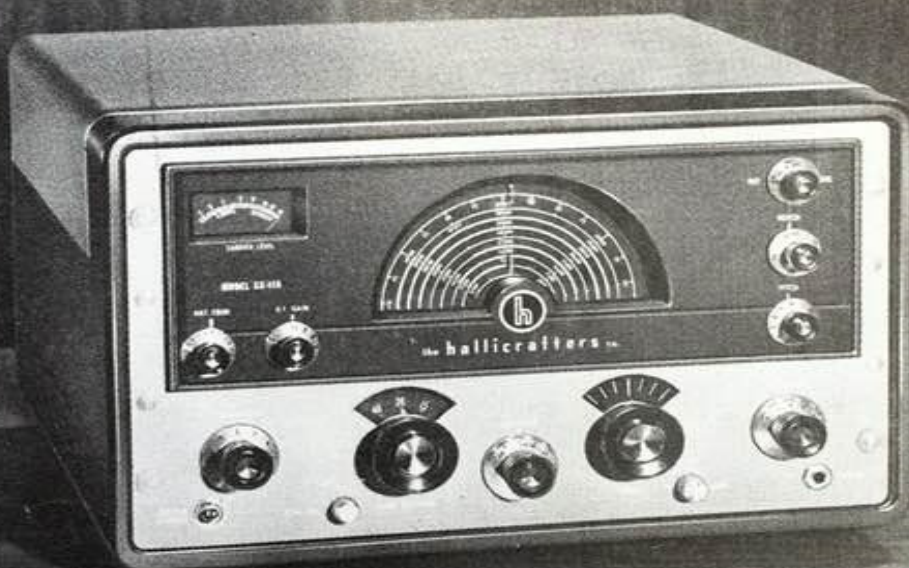
**SX-115**  
RECEIVER

- Band-pass filter front end—equivalent of four tuned circuits preceding 1st mixer.
- Crystal-controlled high frequency oscillator.
- 5 steps of selectivity plus Hallicrafters' exclusive upper/lower sideband selection.
- Linear CTO, direct reading in kc.

The experienced amateur will immediately recognize in the SX-115 a first rate engineering triumph that creates an *entirely new class* of deluxe receiver.

**Frequency coverage:** Nine 500-kc segments covering 3.5–4.0 mc.; 7.0–7.5 mc.; 14.0–14.5 mc.; 21–21.5 mc.; 28.0–30.0 mc.; (4 segments); and WWV.

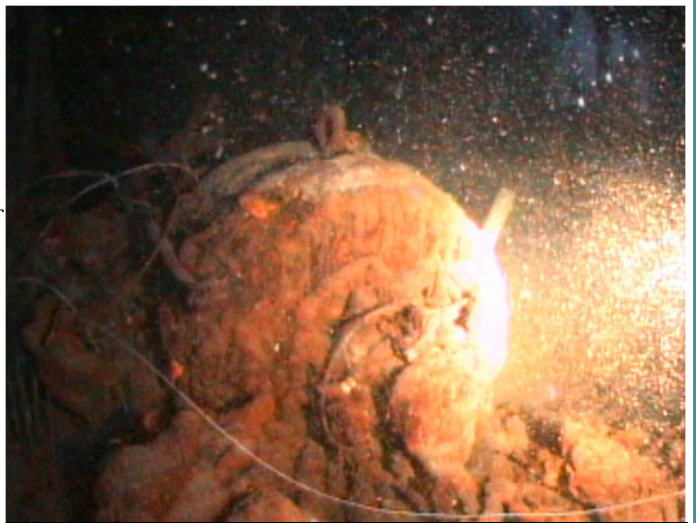
Above: this DC motor was part of the disk discharger transmitter in the Silent Room which was located just below the main deck, to give the shortest distance between the equipment and the aerials (Earthship Productions Photo)

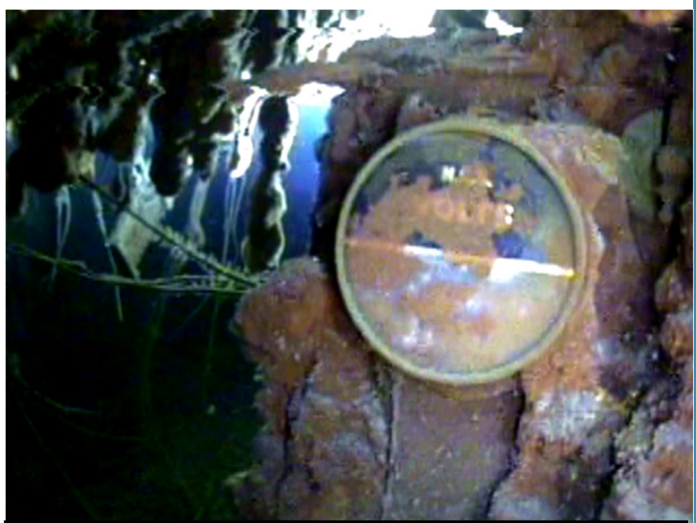
Above: One of the switchboard meters for the 5 kw transmitters (Earthship Productions Photo). Below, right: This was likely the style of meter used on the switchboard for the 5 kw transmitter. (Canadian Museum of Science and Technology Photo)

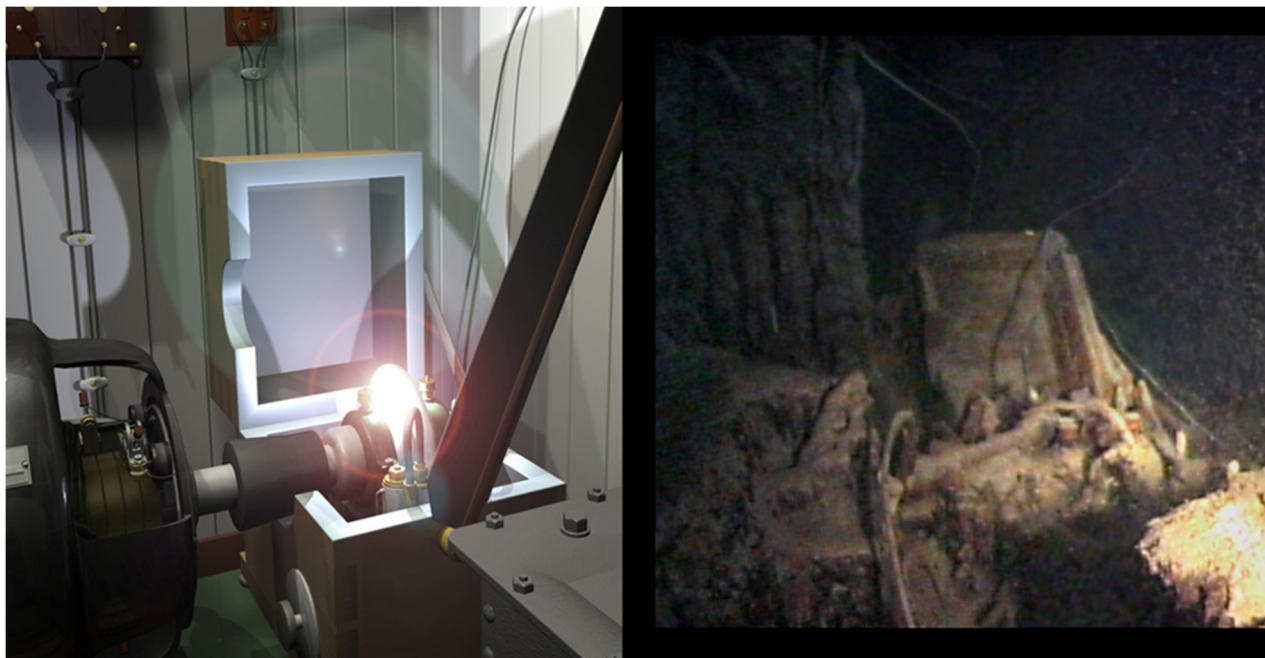
Above left: The disk discharger spark gap sat inside a teak box which served as a sound deadener. The lid of this box is in the open position (CGI by Parks Stephenson). Above right: The disk discharger transmitter as seen in 2019. It is believed that the lid was left open by radio operator Harold Bride. Photo by Earthship Productions

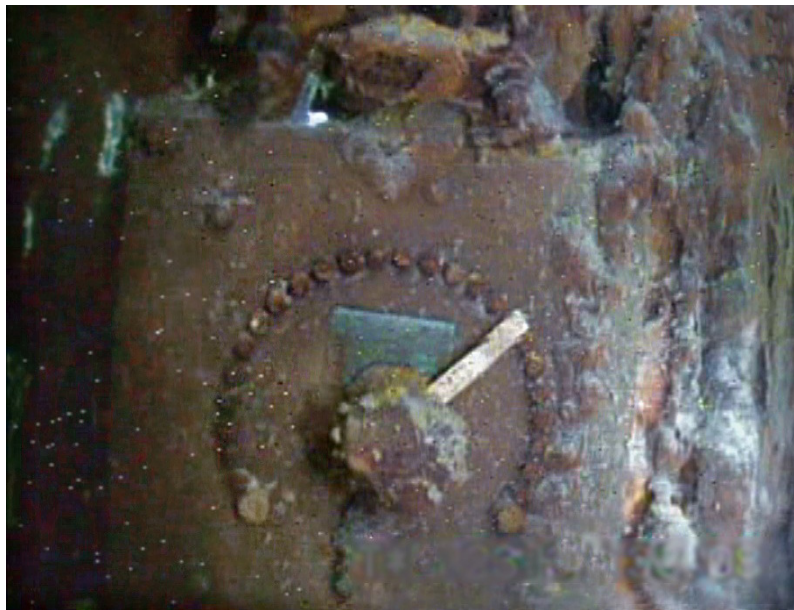
Above: One of the multi-tapped regulator boxes whose selector handle is shown in the exact position when Titanic sank. Photo by Earthship Productions

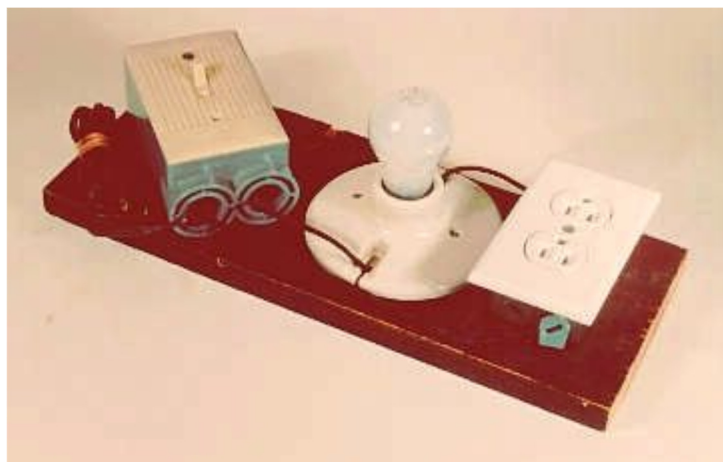
Here's my old dim-bulb tester, which I built about 25 years ago. It's a few spare electrical parts mounted on a piece of scrap wood, and it includes a power switch, although the switch is optional.

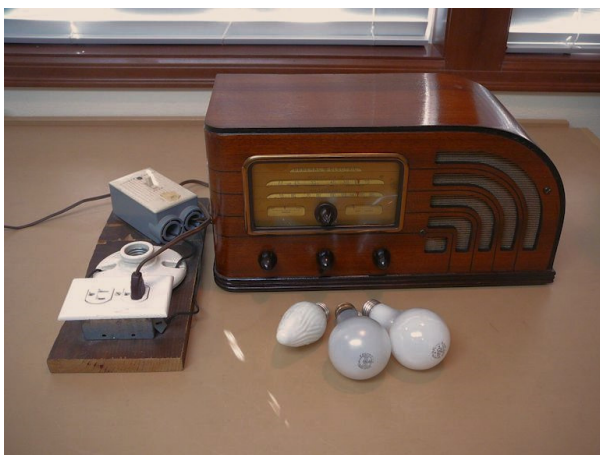
Let's look at a real-world example. The next photo shows my GE F-63. This radio has been fully restored and it works like new. Next to it is my dim-bulb tester and three bulbs, of 40, 75, and 150 watts. I have plugged the tester into the wall and plugged the radio into the tester.

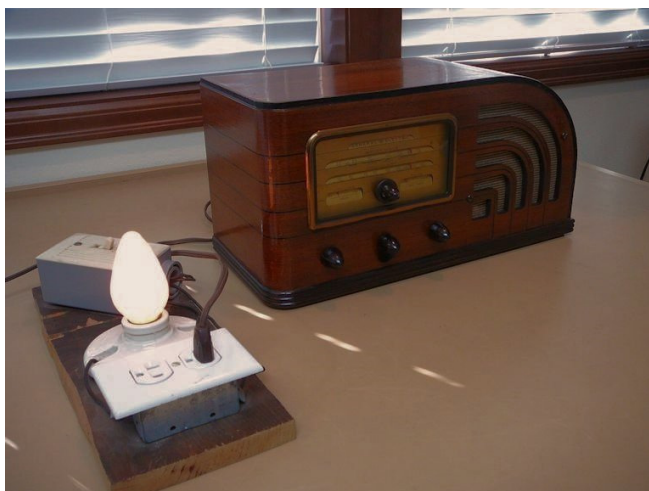
This six-tube GE radio draws 70 watts, according to its label. You would normally use a bulb equal to that or somewhat higher, but let's see what happens when you put a 40-watt bulb in the tester and try to power the radio:

The 40-watt bulb glows very brightly and the radio doesn't play. This is not a sign of trouble—the bulb is simply too small, only a little over half the wattage drawn by the radio. This example shows that there's no point in using a too-small bulb: it won't tell you anything useful.

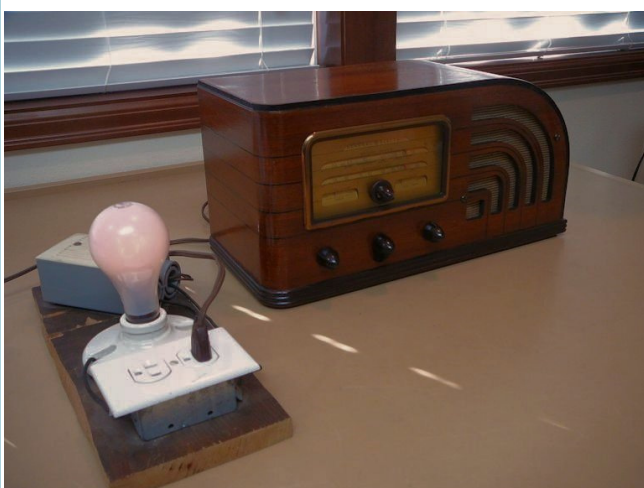
Now, let's substitute a 75-watt bulb, which approximates the radio's 70 watts.

The 75-watt bulb shines dimly—notice the faint pink-orange glow—and the radio plays normally. It takes a few seconds longer than usual to warm up, and the

bulb shines a little more brightly during that warm-up period. This is normal behaviour for a good radio when the wattage of the bulb is roughly the same as the radio's wattage.

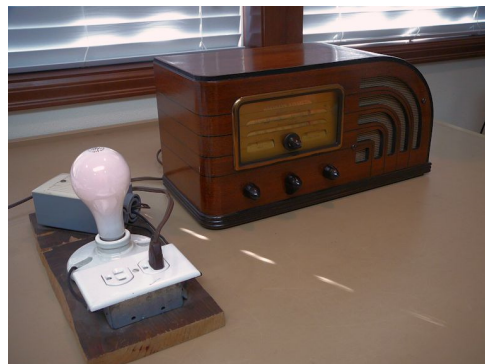
The final example uses a 150-watt bulb, slightly more than twice the radio's wattage.

The 150-watt bulb barely glows at all. The radio warms up quickly and it plays normally. This is what you'd expect from a normally-functioning radio. If this large bulb shone brightly, that would flag a problem.

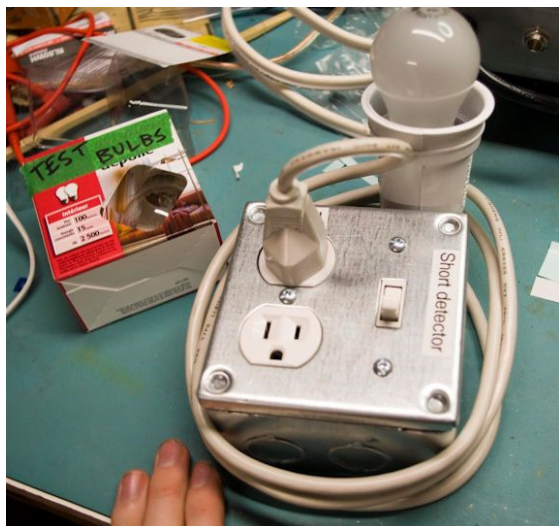
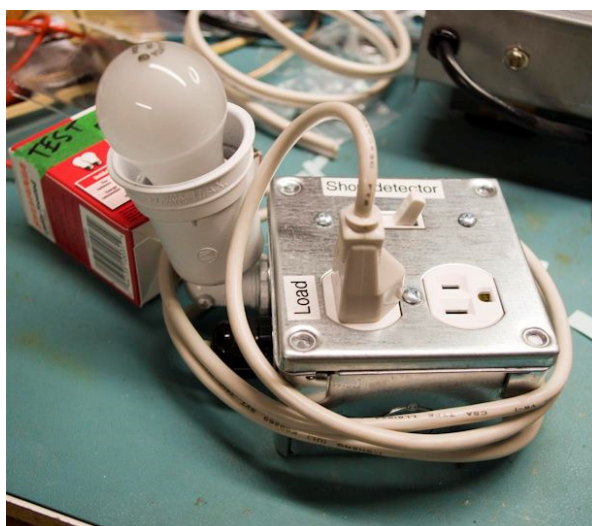
A couple of years ago, Kai Lydestad shared these photos of his dim-bulb tester:

*I don't have a very large bench, so I made this compact version using a floodlamp socket designed to fit a hole the size of a conduit punch-out.*

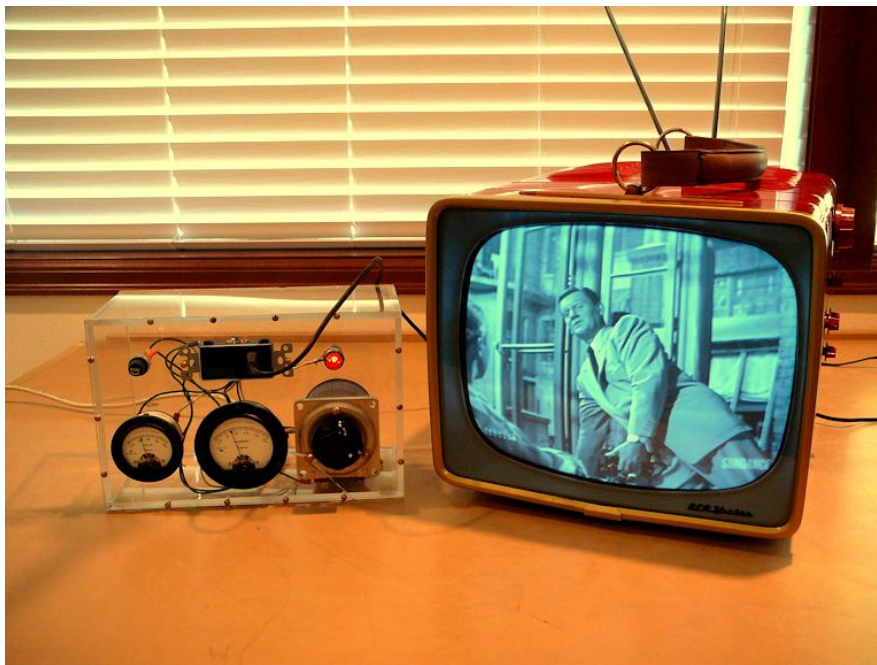
In discussions of trying out unrestored radios or TVs, you'll sometimes hear mention of a variac. A variac isn't equivalent to a dim-bulb tester, but each device has its uses, when testing a vintage tube device. In this photo, I'm playing a restored TV using a variac:

In a nutshell, a variac lets you vary the line voltage supplied to your radio or TV. It's handy for powering a set at a specified voltage (say, 117 volts rather than the usual 120), or for gradually increasing the line voltage while you try out an unrestored set.
